SEISMIC PERFORMANCE EVALUATION OF SCHOOL BUILDINGS CONSIDERING THE POST-DISASTER FUNCTION: CASE STUDY FOR FACILITIES OF PANGASINAN STATE UNIVERSITY, PHILIPPINES

Rizalyn C. Ilumin

*Pangasinan State University, Barangay San Vicente, Urdaneta City,
Pangasinan, Philippines 2428*

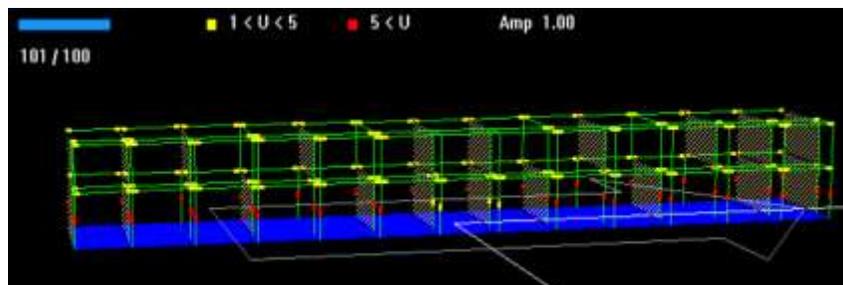
The building's maximum deformation capacity was analyzed using the pushover analysis wherein the gradual loading was exerted. Figure 3 shows that severe damage was concentrated at the first floor of the Engineering Building 2. In STERA 3D, red color indicates a ductility factor greater than 5 and when it was associated to the ductility index, it can induce large displacement. This means that the structure will suffer significant deformation wherein possibility of collapse is high. Furthermore, the yellow color connotes minimal cracking. The second level screening which is a detailed inspection method presented the same result in which the longitudinal direction of the first floor needs retrofitting.

Figure 3. Pushover analysis of the Engineering Building 2.

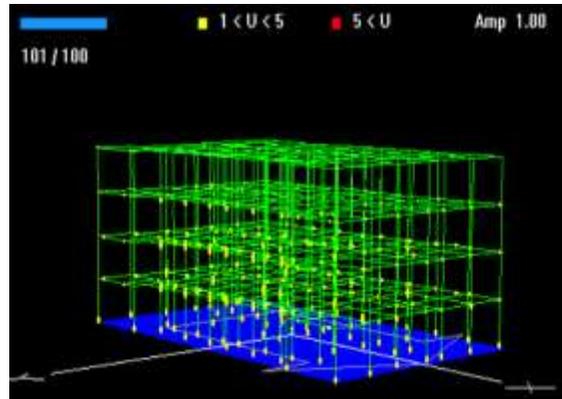
The newly constructed soft story building was also analyzed using pushover analysis. The result showed that this building has a few severe damages at the first floor while the rest of its floors has minor damages as shown in Figure 4. Even though there was a few red color which means serious damage on the particularly area, still strengthening must be considered. The result from the second level screening gave the same remarks that first story should be retrofitted.

Figure 4. Pushover analysis of the Administration Building.

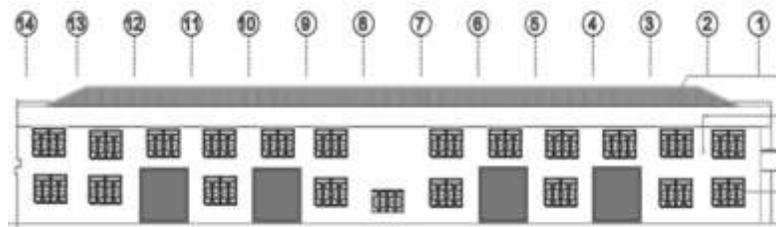
Figure 5. Rear elevation of the Engineering Building 2 showing the location of shear walls.

The vulnerable buildings were retrofitted using the reinforced concrete shear wall to upgrade their seismic capacity. The contributions of the infilled shear panels to the vertical members of structures were verified utilizing the second level screening. Furthermore, they were modeled in STERA 3D and the technical manual version 5.8 which was also written by Saito (2017) was used to fully understand the notion behind the gathered results. Figures 5 and 6 show the location of the four and three RC shear panels of the Engineering Building 2 and Administration Building, respectively. The 16mm diameter anchors served as connectors to be installed around the existing frame with the effective embedment length of 160mm. Figure 6 shows the improved strength of the structures indicating the effectiveness of RC shear wall.

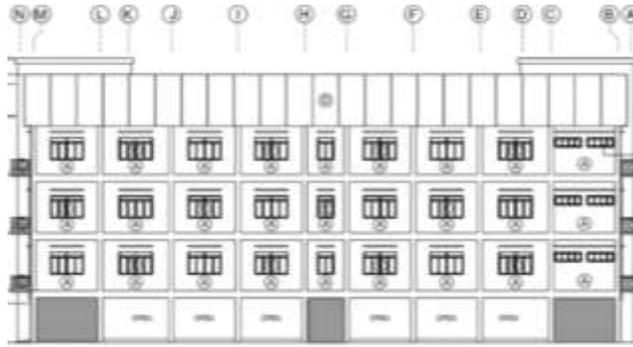
Figure 6. Rear elevation showing the location of shear walls.
