CASE REPORT

Esthetic Rehabilitation of Traumatically Fractured Anterior Tooth with Glass Fiber Reinforced Composite Post and Core- A Case Report

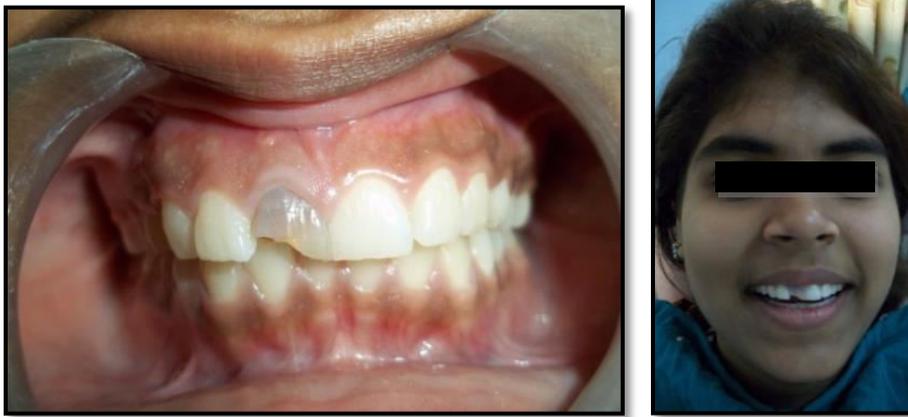
Figure 1: Pre-operative A) Intra oral view B) Extra oral view

A 16-year-old female patient reported to the department with a chief complaint of broken upper front tooth. The patient presented with crown fracture of her right maxillary central incisor. The history of trauma dated back to about two years when the patient had a fall while playing at home with siblings. At the time of injury, there was no bleeding and no medical or dental consultation was sought. The patient gave no history of pain when she came to our department. Her medical history was non-significant. On extra-oral examination, no significant findings were found. On intra-oral examination, there were no lacerations or evidence of alveolar bone fracture or any gingival inflammation. The right maxillary central incisor showed Ellis Class III fracture, with Grade I mobility and blackish discoloration. [Figure 1] The tooth was non-vital, with no response to the electric pulp test and other vitality tests. Radiographic examination showed complete root end development in the tooth of interest. [Figure 2A] The patient and parents were given detailed information about the treatment plan. An informed written consent was taken.

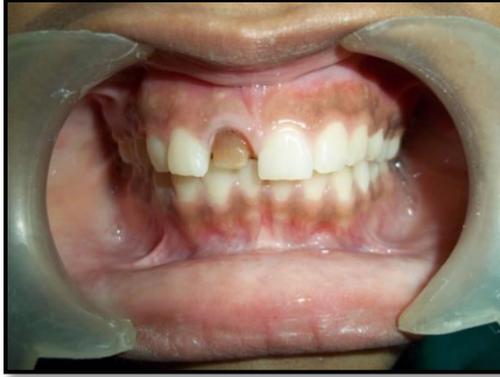
Figure 5: Tooth preparation for PFM crown

An intra-oral periapical radiograph was taken to confirm the post space and the fit of the post. Acid etching of canal was done with a 37% phosphoric acid gel for 20 seconds. Subsequently, the canal was rinsed copiously with water for 20 seconds and air dried with a gentle stream of air, making sure that there was no desiccation. Bonding agent was applied in the etched canal and light cured for 10 seconds. Then the glass fiber-reinforced composite post was placed into the canals up to the measured space, using a flowable composite [Figure 3]. The core build up was done with composite resin using the incremental technique and occlusal adjustments were made [Figure 4]. Then the tooth was prepared and after adequate gingival retraction, impressions were taken using silicon putty impression material [Figure 5, 6]. Complete coverage porcelain-fused-to-metal crown was fabricated and after evaluation of the crown in occlusion it was luted using Type I glass ionomer cement [Figure 7].

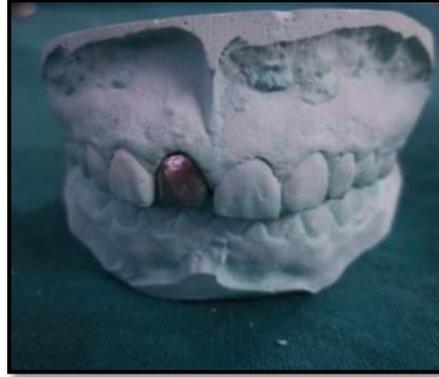
**Figure 6: Metal coping in 11**

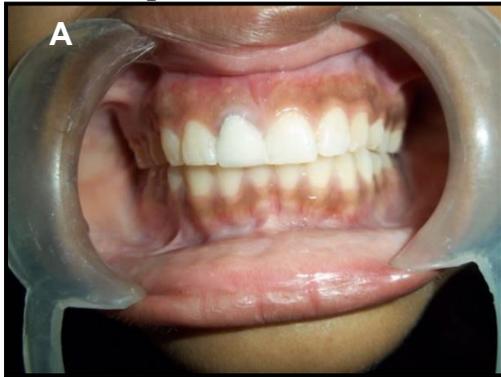
**Figure 7: Post-operative A) Intra oral view**

**B) Extra oral view**
