Evaluating the effect of intentional perforation of dental implants into the maxillary sinus in different depths (Stability and Radiographical study)

ABSTRACT: *The sinus membrane perforation combined with exposing dental implant into the maxillary sinus is considered as a potential risk factor for implant failure and sinus complication. The present study investigated the incidence of intentional sinus membrane perforation by dental implant in different depths and the possible risk factors associated with membrane perforations and assessed the implant osseointegration and the survival rate of implants placed in the posterior maxilla in a dog model. A total of 32 titanium implants were placed in the bilateral maxillary first molar areas of 16 adult mongrel dogs with different penetrating depths of implants into the maxillary sinus cavities (group A: 0 mm; group B: 1 mm; group C: 2mm; group D: 3 mm). The sample, block biopsies were harvested six months after surgery and evaluated by Biomechanical analysis and radiographic observation. After six months healing period, no signs of inflammatory reactions or complications were observed in any maxillary sinus of the sixteen dogs. The res

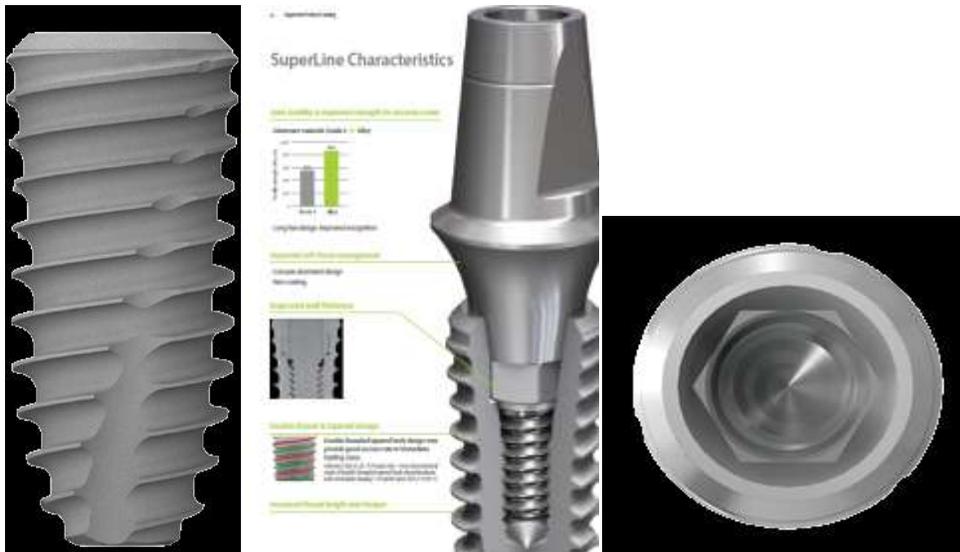
Figure (1) Dentium-SuperLine fixture

In the present study, Dentium-SuperLine fixture tapered type, endosseous dental implant (Dentium Co., Ltd, Sangpil Yoon, 150, Eondong-ro, Giheung-gu, Gyeonggi-do 443-270 KOREA), made of Pure Titanium grade 4; 4 mm diameter and 10 -12 mm length is selected to be used in this study (Fig 1).

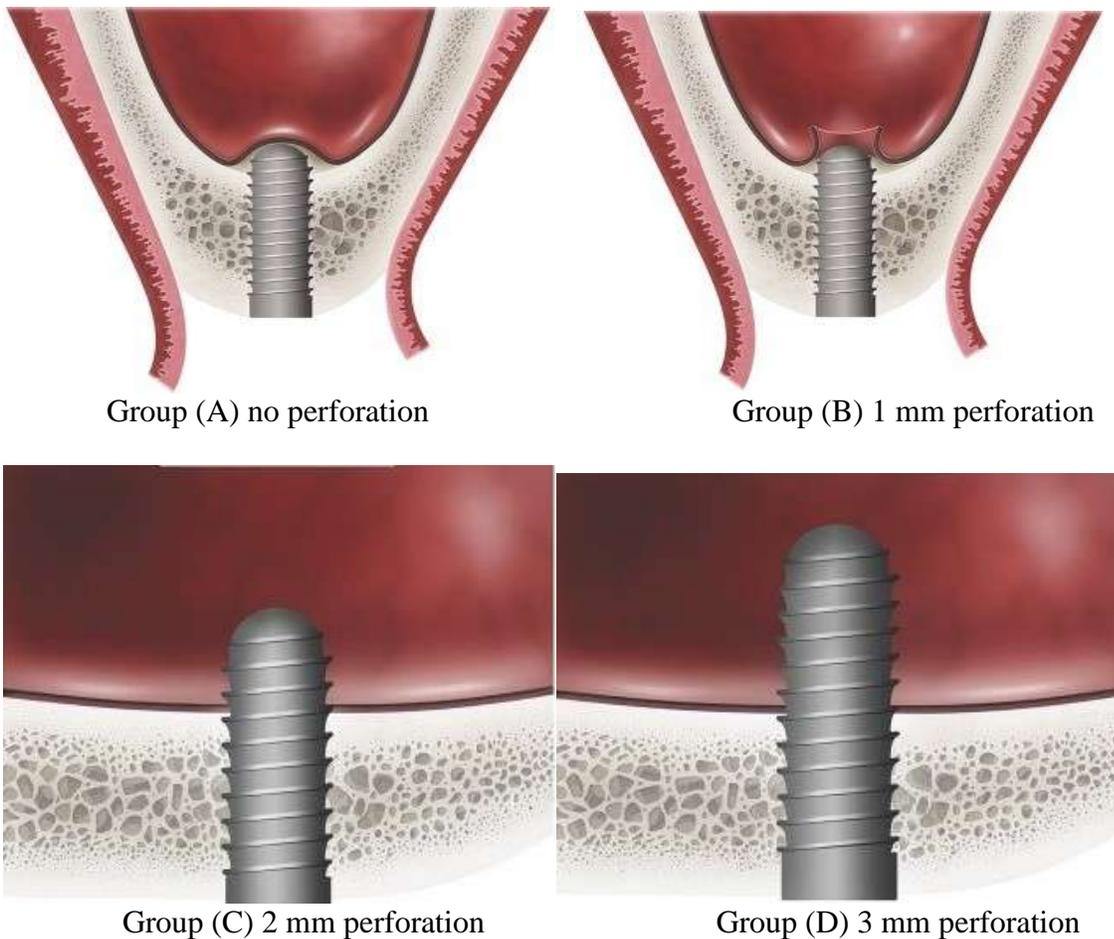
Figure (2) Graphic representation of experimental groups A-D

A split-mouth randomized design, using four treatment protocols on the positions of bilateral maxillary first molars, was employed. A total of (32) dental implants were used in this study. Each implant recipient site was randomly assigned to one of the four treatment protocols, and immediate implant placement was applied accordingly as follows and as illustrated in figure (2; A-D)

- 1-) group A (n=8) was control group without sinus floor penetration;
- 2-) group B (n=8) with penetrating depth of 1 mm;
- 3-) group C (n=8) with penetrating depth of 2 mm;
- 4-) group D (n=8) with penetrating depth of 3 mm

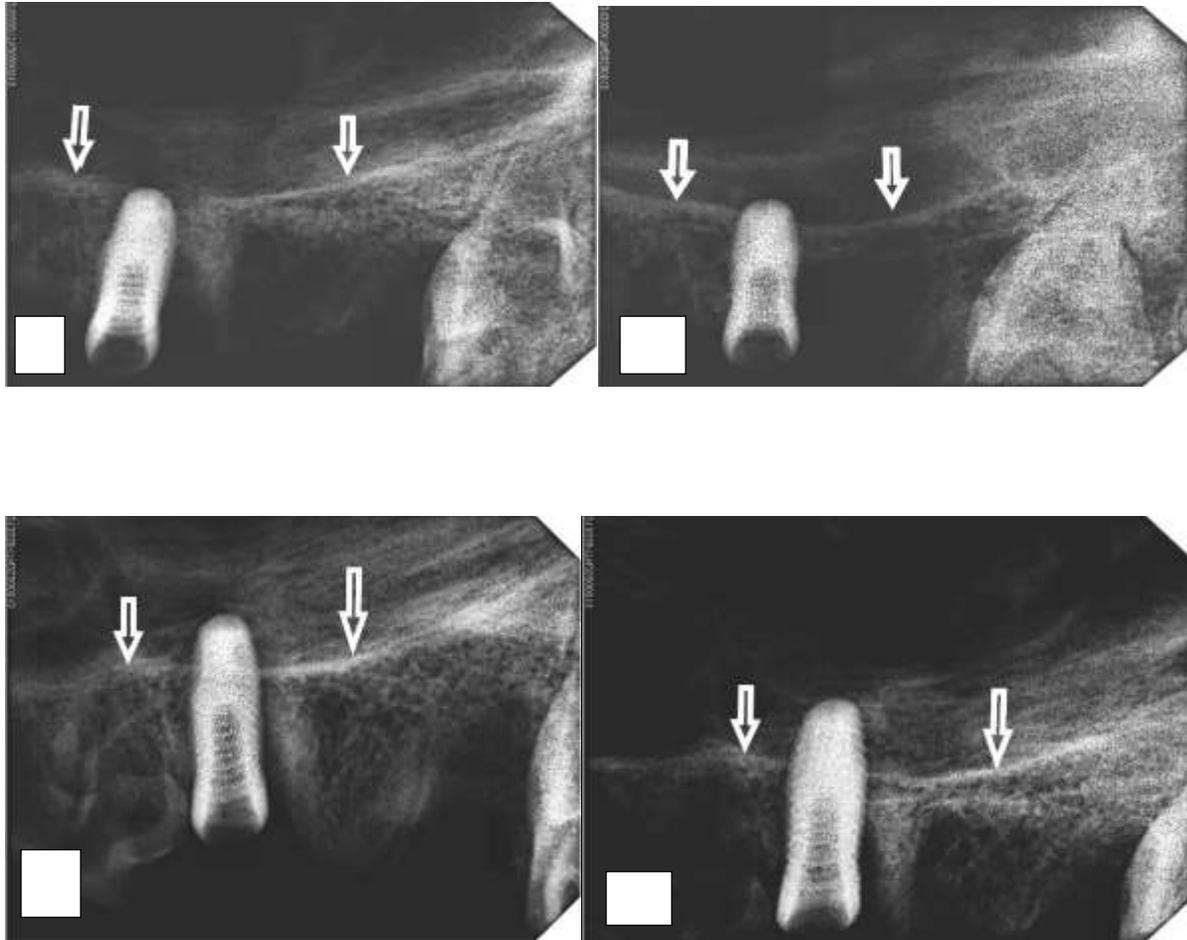
Figure (4) Plain periapical radiographs for inserted implants in four different depths (A= 0 mm; B= 1mm; C= 2mm; D= 3mm)

The surgical insertion of the dental implants was carried out immediately after teeth extraction. Thirty two sterile threaded cylindrical implants of grade 5 pure titanium were placed (Fig 3). Except the control group, (group A (n=8) without sinus floor penetration), eight implants were placed within the alveolar bone without protruding into the sinus cavity. The other twenty four implants were placed bilaterally in the sinus cavity in such a manner that they penetrated the bone and mucous membrane of the maxillary sinus floor to the extent of 1 mm (group B), 2 mm (group C) and 3 mm (group D), respectively (Fig 4).

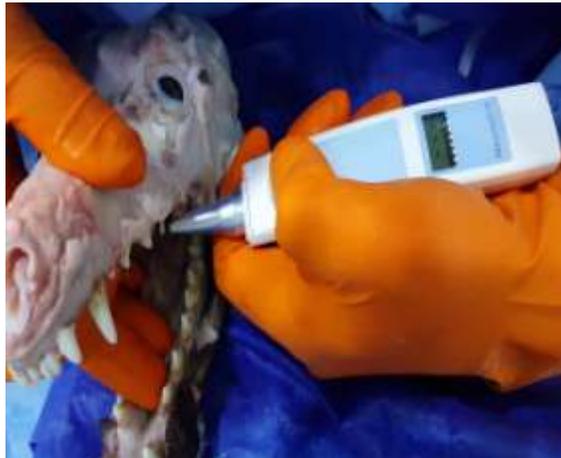
Figure (5) Secondary stability measurement

At the end of the experimental six months healing period, the animals were sacrificed by administration of an over dose of ketamine hydrochloride (Jimboet *al.*, 2013). The surgical site was reopened by a small incision and the dental implants were exposed carefully then, implant abutment were adapted to the implant fixtures, then the secondary stability reading was measured with the same technique as that followed in the primary one (Fig 5).

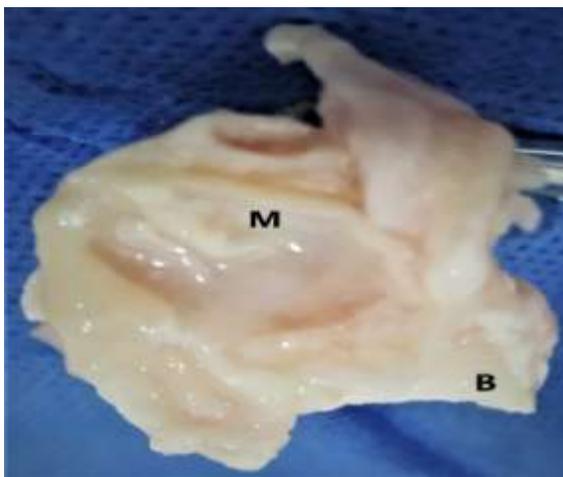
Figure (6) Sample block. Bone (B) and Sinus membrane (M)

After dissection of the jawbones, each implant with a preserved 5-mm thickness of peri-implant bone was removed as one piece of sample. The membrane adjacent to the implant was separated and removed.

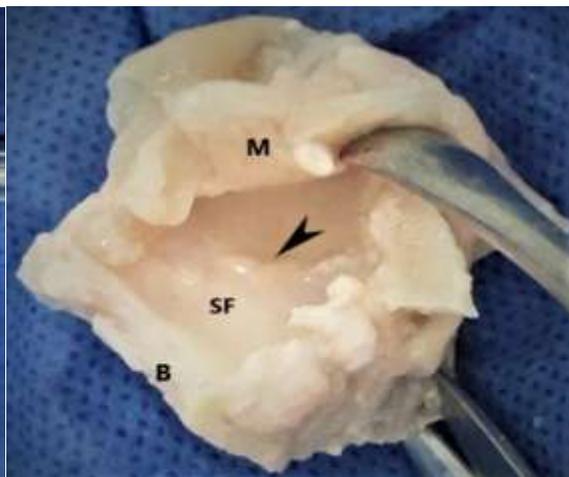
Figure (7) Separation of sinus membrane (M) from bone (B) and sinus floor (SF)

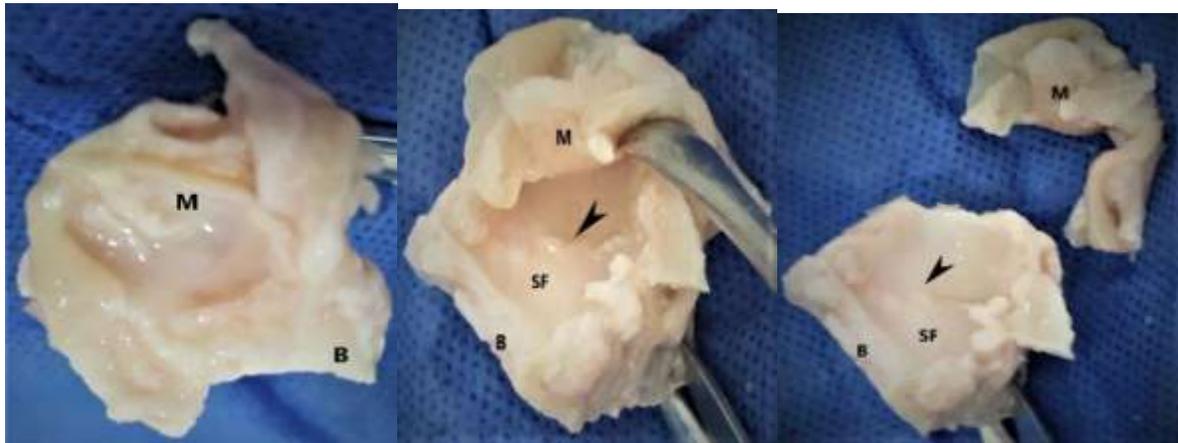
Figure (8) Gross observation of the apical portion of the implant in the sinus cavity. The bony sinus floor in the control Group (A) remain intact without implant exposure (arrow). SF: sinus floor; M: membrane; B: bone of the lateral sinus wall

The bone at osteotomy site and membrane of sinus floor remained intact healthy without signs of inflammation in the control group (A) (Figure 8). In group (B) and group (C), the protruding parts of implants that had been introduced into the sinus cavity for 1mm and 2 mm were fully re-covered with a thin layer of newly formed membrane with a healthy appearance and no inflammatory reaction was observed in the surrounding sinus membrane. Regenerated bone tissue was discovered on the upper most part of some implants (Figures 9 and 10). In group (D), the parts of implants that had been penetrated into the sinus cavity for 3 mm were totally exposed in the sinus cavity with the membrane surrounding the base of protruding parts, circular epithelium structure similar to gingival cuff formed around the base of the protruding parts and did not show any signs of inflammation (Figure 11).

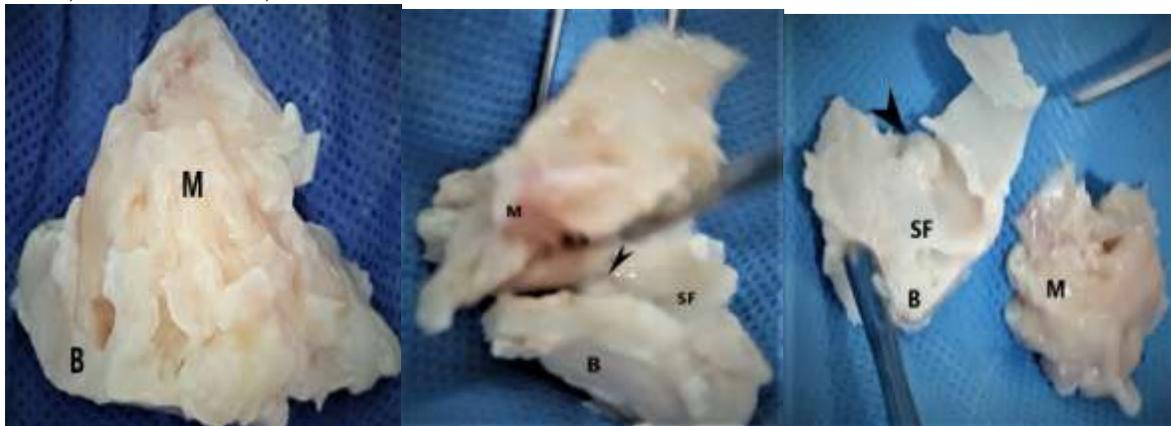
Figure (9) Gross observation of the apical portion of the implant in the sinus cavity. The tips with protruding depth of 1mm Group (B) were partially covered with new bone and scars were left at

the penetrating spots on the membrane (arrow). SF: sinus floor; M: membrane; B: bone of the lateral sinus wall.

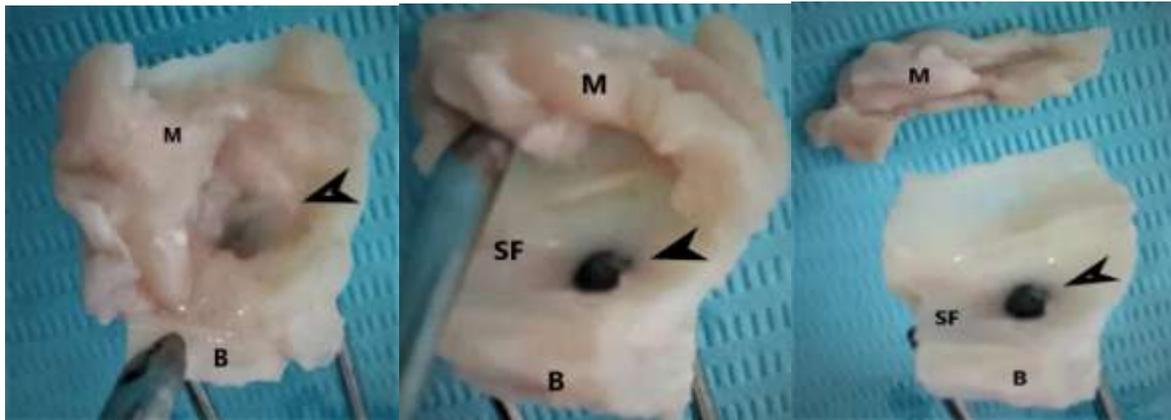
Figure (10) Gross observation of the apical portion of the implant in the sinus cavity. The tips with protruding depth of 2mm Group (C) were partially covered with new bone and scars were left at the penetrating spots on the membrane (arrow). SF: sinus floor; M: membrane; B: bone of the lateral sinus wall.

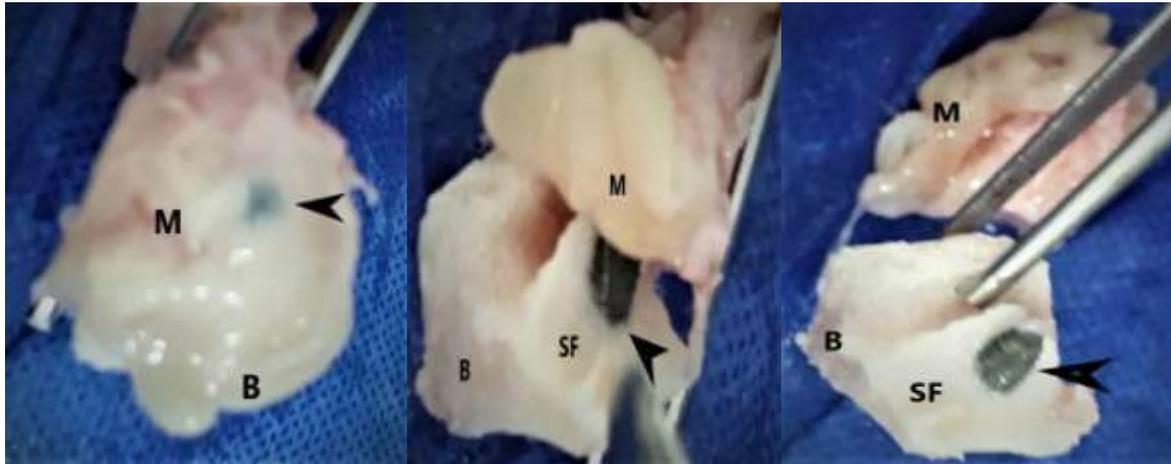
Figure (11) Gross observation of the apical portion of the implant in the sinus cavity. The implant tip with protruding depth of 3mm group (D) was totally exposed in the sinus cavity with no bony coverage and the penetrating hole was left on the sinus membrane (arrow). SF: sinus floor; M: membrane; B: bone of the lateral sinus wall.

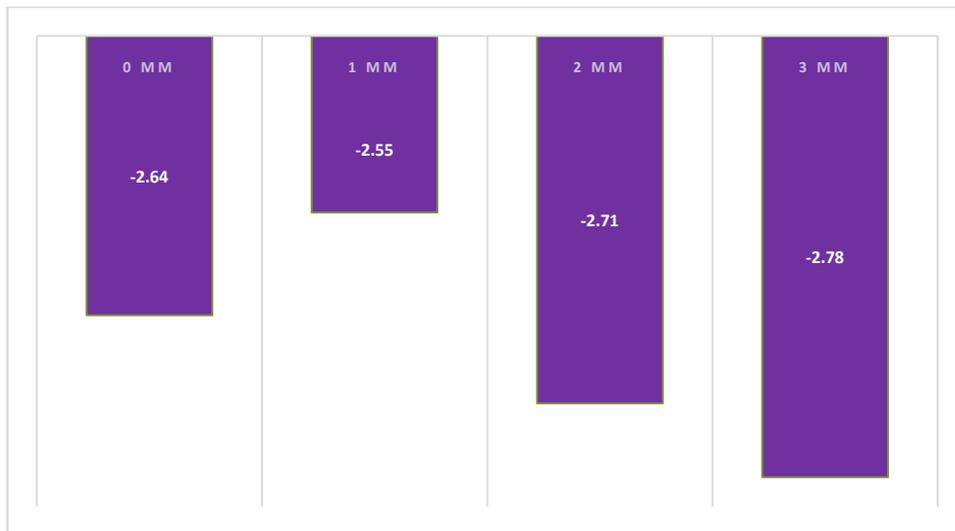
Figure (12) Chart diagram for the primary stability of the four groups.

The results of the ANOVA statistical analysis showed non-significant differences ($P = 0.832$) between the values of Primary stability for the four groups, as shown in figures (3.7 and 3.8).

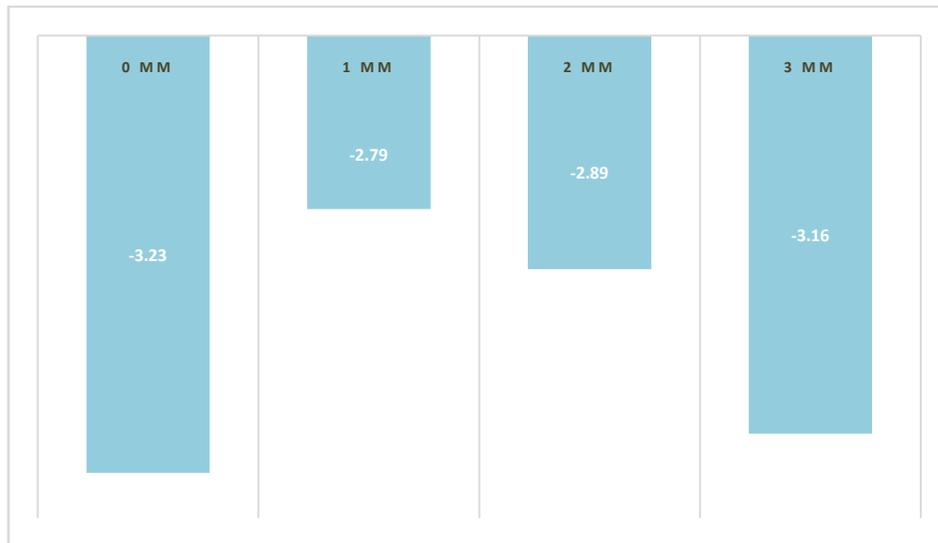
Figure (13) Chart diagram for the secondary stability of the four groups.

The results of the ANOVA statistical analysis showed non-significant differences ($P = 0.463$) between the values of secondary stability for the four groups, as shown in figures (3.9 and 3.10).

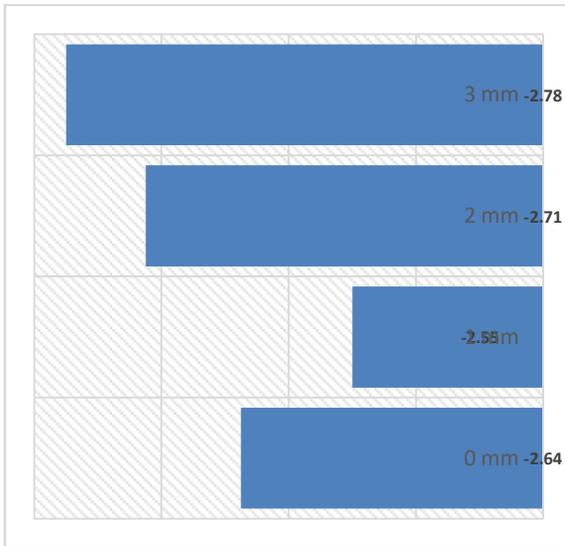
Figure (14) Chart diagram for the primary stability of the four groups

In the current study, the Paired Samples t-test results showed non-significant differences (P-value) in the Periotest values between the Primary stability and the Secondary stability measures of all the groups, as shown in table (3),and figures(14 and 15).

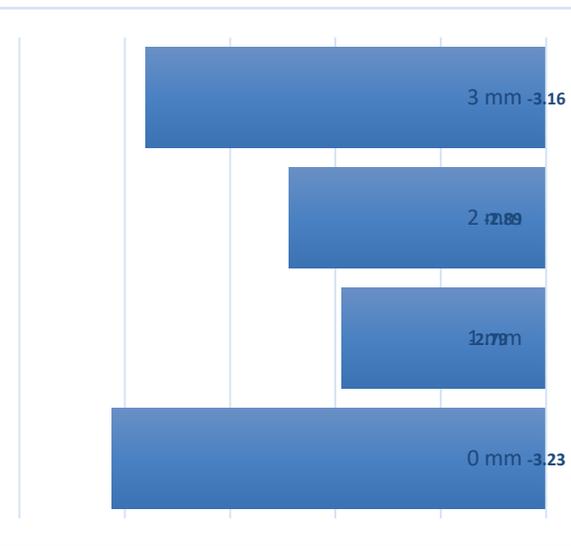
Figure (15) Chart diagram for the secondary stability of the four groups.

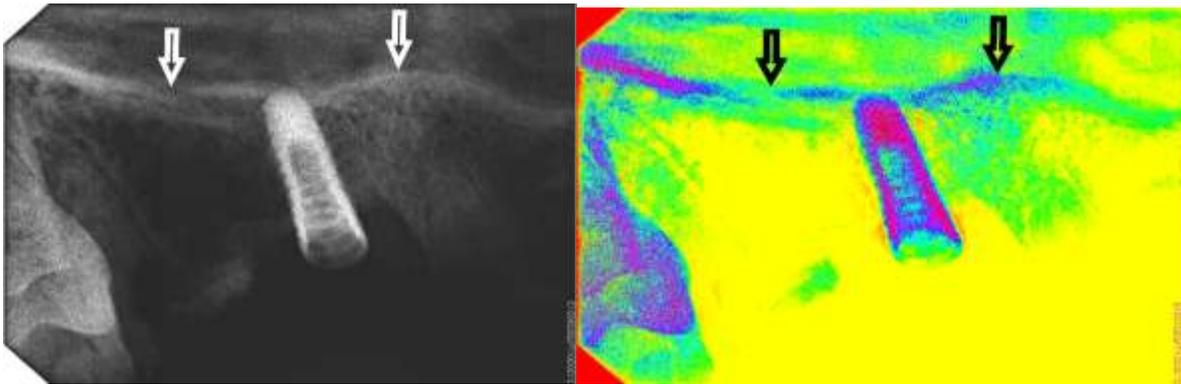
Figure (16) Radio graphic examination pictures of the sites of implantation .The tips of implants in the control group (A= 0 mm) were completely embedded in the alveolar bone. Arrows indicate the bony sinus floor.

Radiographic examination of the sites of implantation demonstrated a close contact of bone and implant without radiolucent areas. The tips of implants in the control group (**Group A**) were completely embedded in the alveolar bone and no signs of inflammation had been seen at pre-implant area (Figures 16).

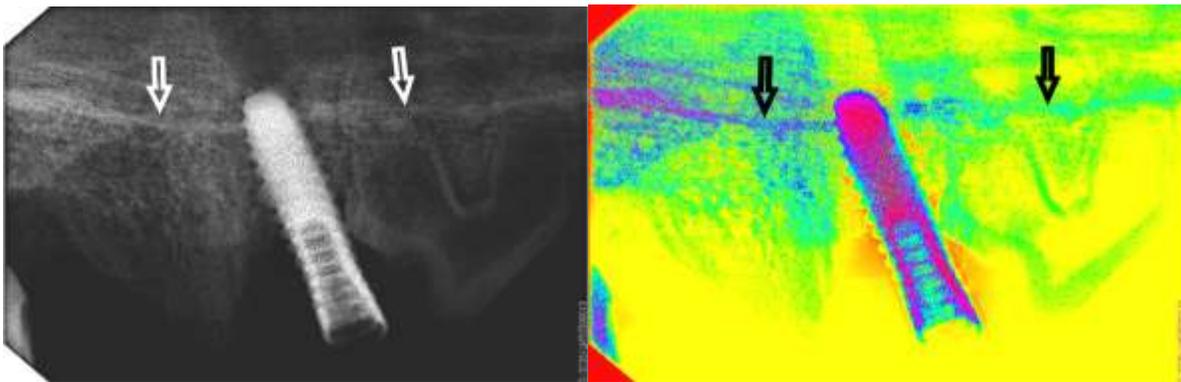
Figure (17) Radio graphic examination pictures of the sites of implantation . The tips of implants with penetrating depth of (B=1 mm) were surrounded by bone tissue . Arrows indicate the bony sinus floor.

The tips of implants with the penetrating depth of 1 mm (**Group B**) and 2 mm (**Group C**) were surrounded by bone tissue with close contact near the tips of some of implants without any significant signs of inflammatory reaction. (Figures 17 – 18). While the tips of implant with the penetrating depth of

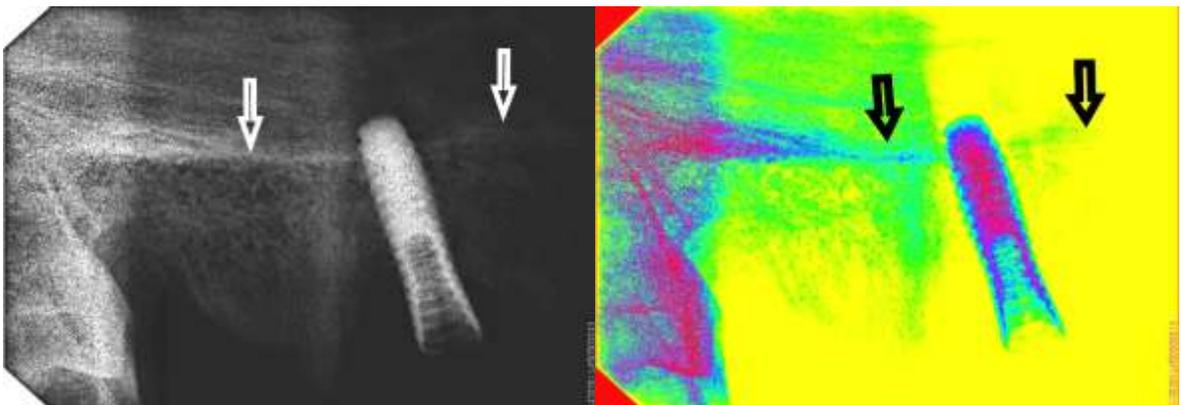
Figure (18). Radio graphic examination pictures of the sites of implantation . The tips of implants with penetrating depth of (C=2 mm) . Arrows indicate the bony sinus floor.

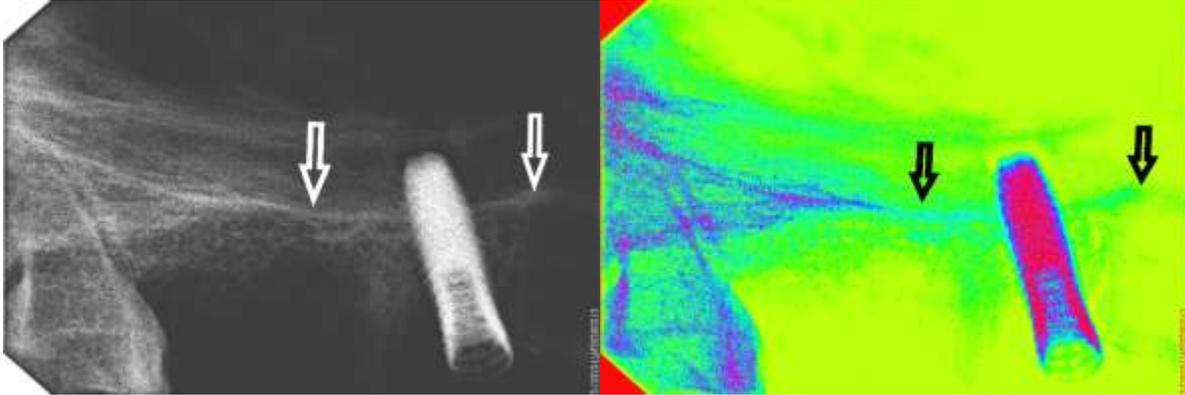
Figure (19). Radio graphic examination pictures of the sites of implantation. The tip of implant with the penetrating depth of (D=3 mm) was found to protrude inside the sinus cavity with no bone coverage . Arrows indicate the bony sinus floor.

3 mm (**Group D**) were found to protrude inside the sinus cavity without bone coverage without radiolucent areas around the implant (Figures 19).

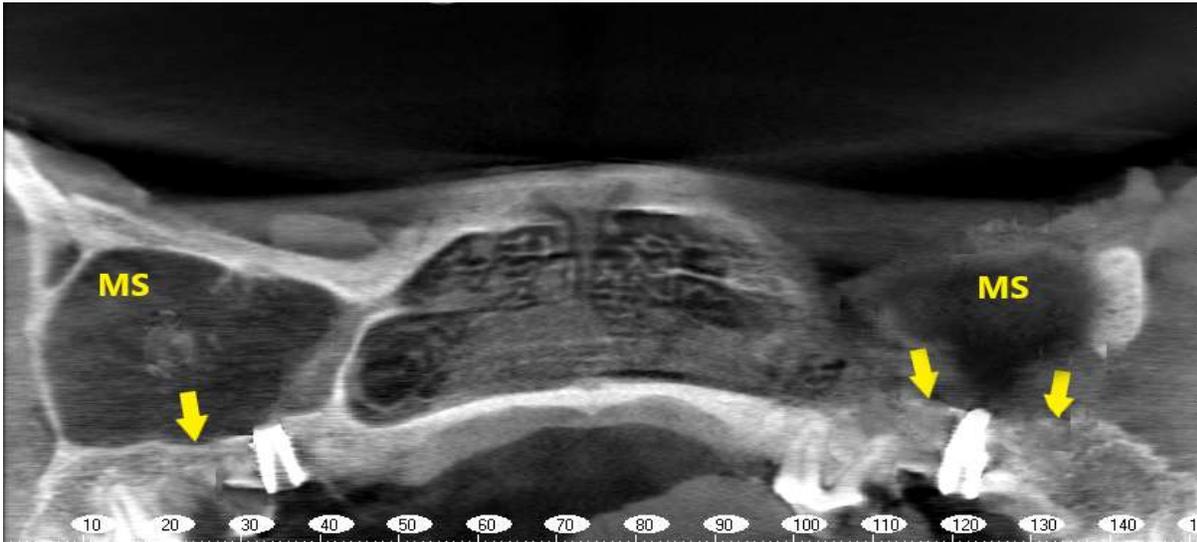
Figure (20).Panoremic view of CBCT shows implant with 0 mm perforation at right side and 1mm perforation at left side of the maxillary sinus. Arrows indicate the bony sinus floor.

A DICOM viewing software program was used to analyze the images. The images were reconstructed with a slice thickness of 0.5 mm and a slice interval of 1.5 mm. The CBCT images were evaluated by a certified oral and maxillofacial radiologist. There was a calibration session prior to initiation of image evaluation to understand the purpose of the study and a training session was conducted to understand the various functions of the reconstruction software.

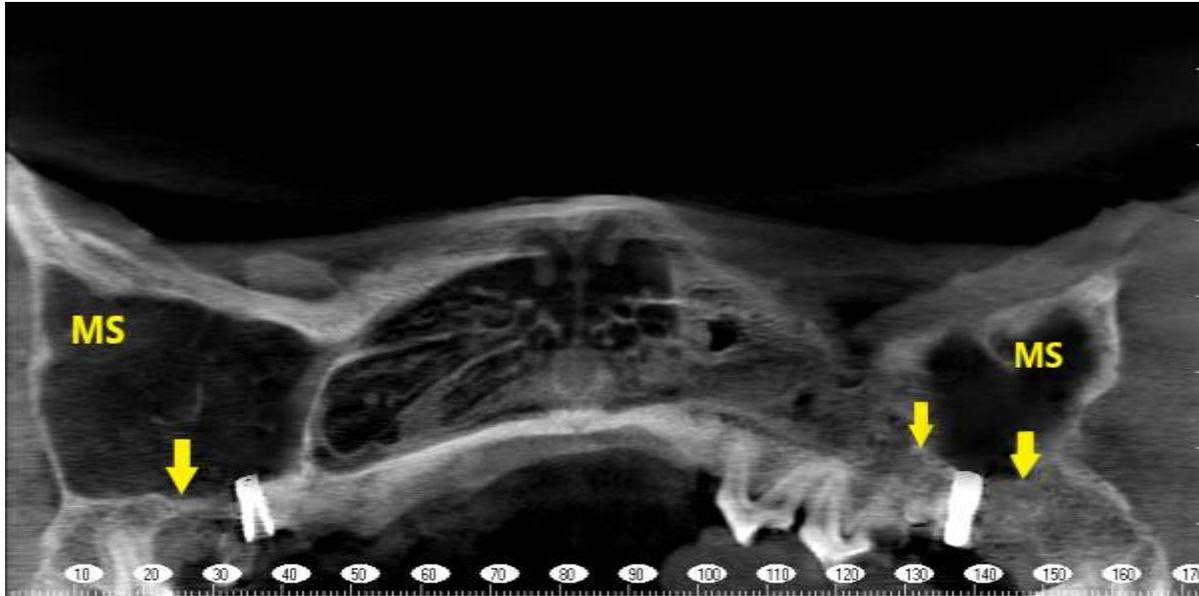
Figure (21).Panoramic view of CBCT shows implant with 1 mm perforation at right side and 0 mm perforation at left side of the maxillary sinus. Arrows indicate the bony sinus floor. MS: Maxillary sinus

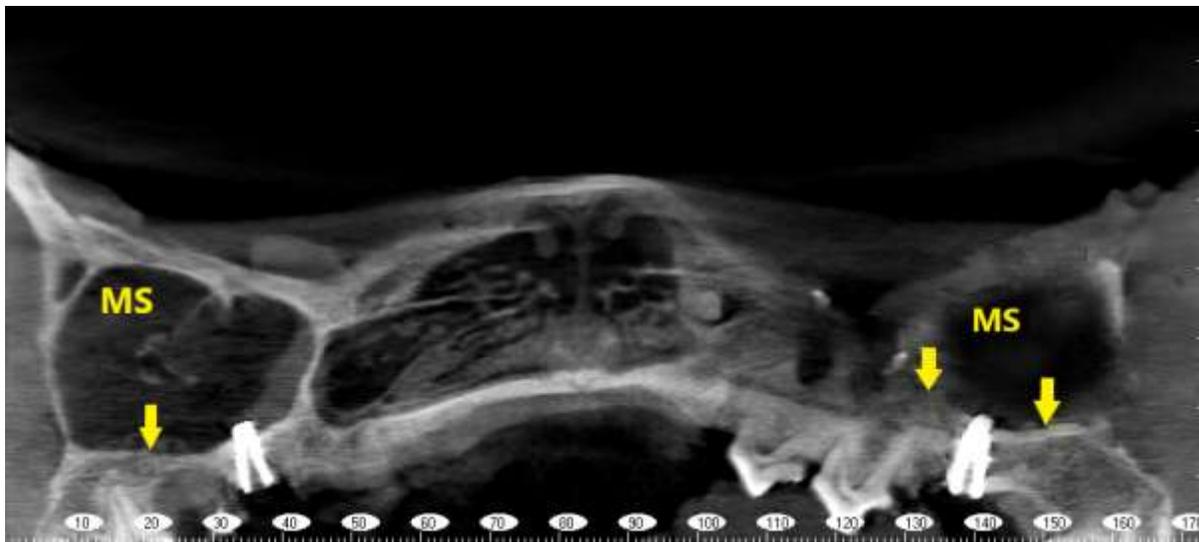
Figure (22).Panoramic view of CBCT shows implant with 2 mm perforation at right side and 1mm perforation at left side of the maxillary sinus. Arrows indicate the bony sinus floor. MS: Maxillary sinus

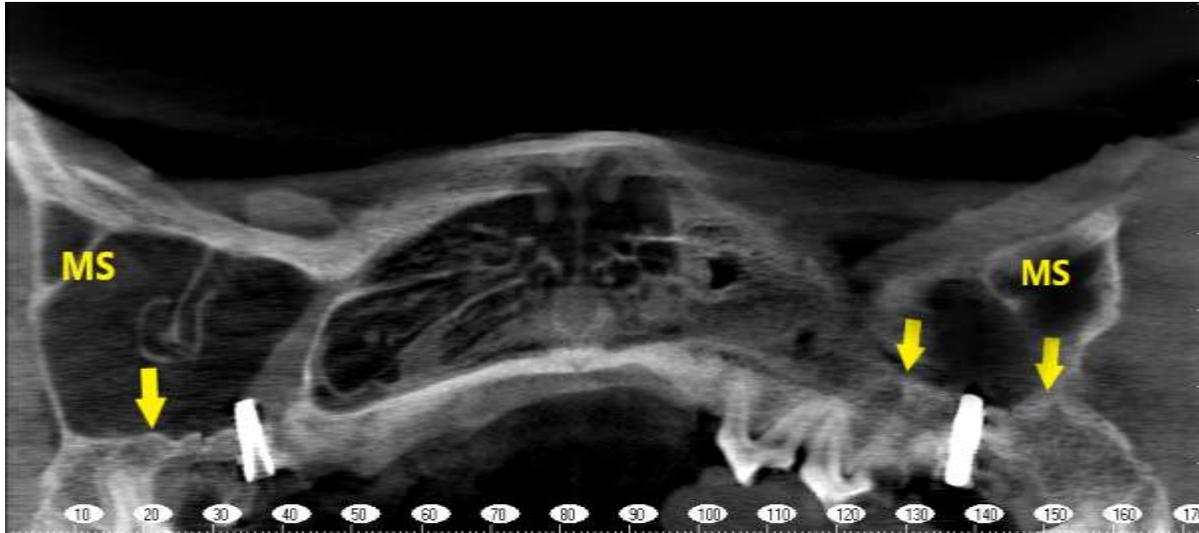
Figure (23).Panoramic view of CBCT shows implant with 3 mm perforation at right side and 1mm perforation at left side of the maxillary sinus. Arrows indicate the bony sinus floor. MS: Maxillary sinus

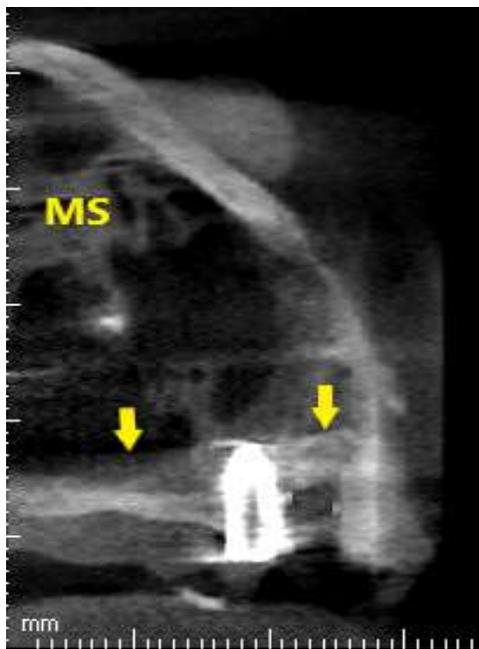
Figure (24) a) Cross view of CBCT shows 0 mm perforation into the maxillary sinus

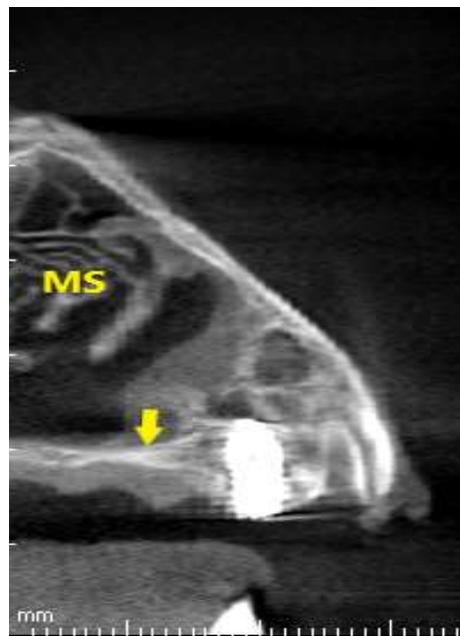
b) Cross view of CBCT shows 1 mm perforation into the maxillary sinus

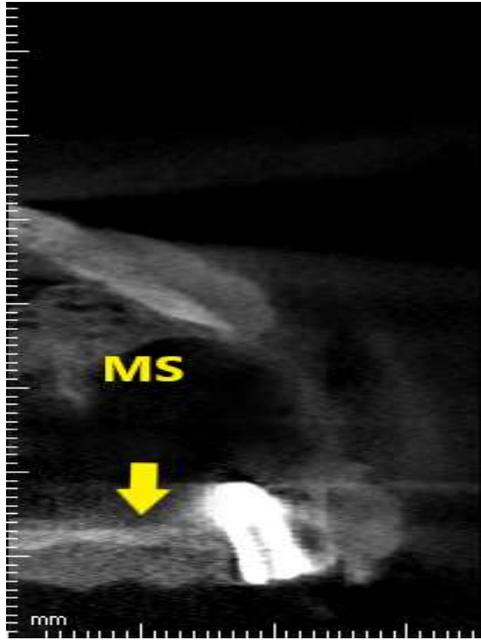
c) Cross view of CBCT shows 2 mm perforation into the maxillary sinus

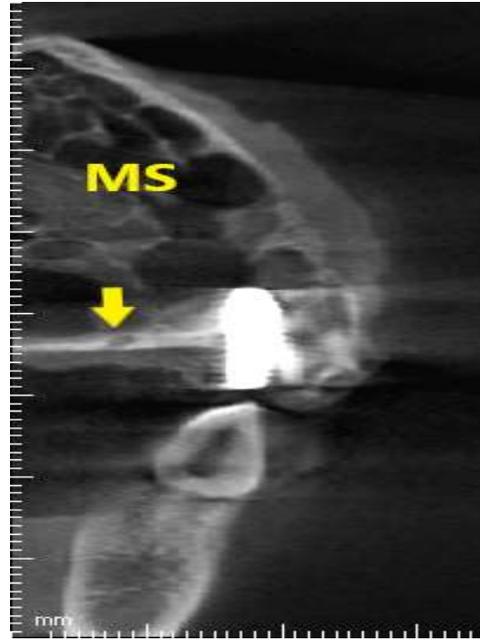
d) Cross view of CBCT shows 3 mm perforation into the maxillary sinus
