Determining the effect of pre-heating on different material weld joint of P&H-11 casting and mild steel plate

Abstract

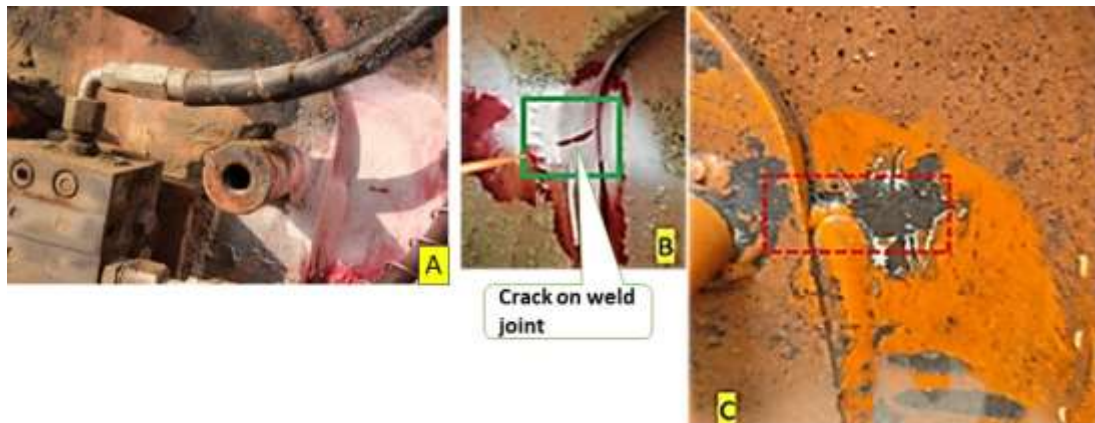
Once the component failed in an application, the part was called for failure analysis at the quality control laboratory. Further visual inspection was carried out before nondestructive testing. The crack location in the failed part has been explained in Figure 2.

Figure 2. A: Initial crack observation on the welded fillet joint. B: Confirmation of crack by dye penetrant testing. C: Visual inspection of crack location after the cleaning of the joint.

- Welding visual: No visual defect observed.
- Welding size: As per drawing specification
- Welding length: As per the drawing specification

Hence, no visual defect is observed in failed part; all the checkpoints were as per the drawing.

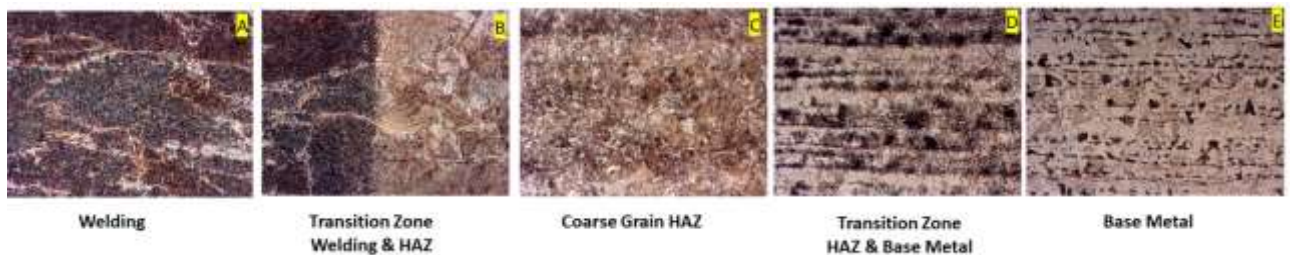
The microstructure study from welding to plate zone has been explained in Figure 7.

Figure 7. Microstructure study from welding to plate zone

- Fig 7A: Columnar grains Welding was free from any non-metallic inclusion. : OK
- Fig 7B: Columnar grains with low carbon bainitic structure. OK
- Fig 7C: Low carbon bainitic coarse grain heat affected zone: OK
- Fig 7D: Low carbon bainitic and ferrite-pearlite mixture: OK

- Fig 7E: Normalized. Pearlite and ferrite mixture is visible: OK

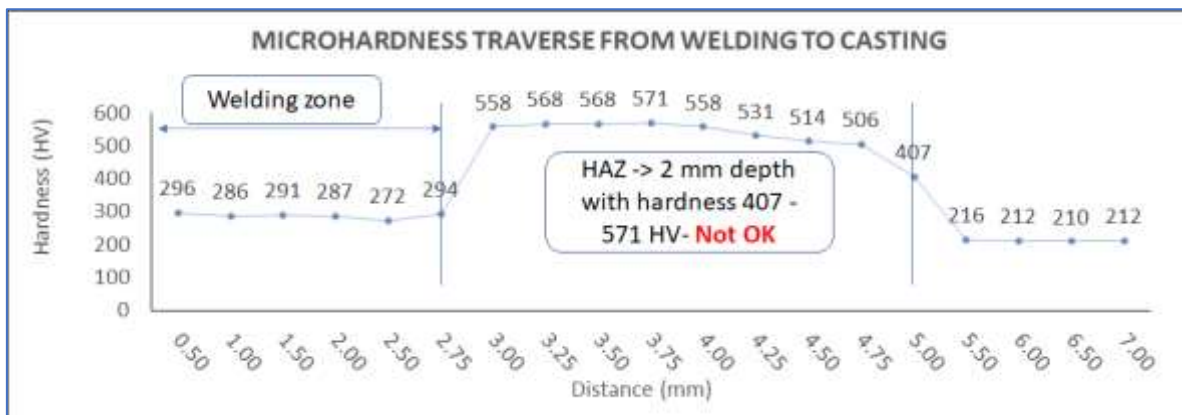
Welding – heat affected zone – Base metal (casting side) microhardness examination has been explained in Figure 8. The Hardness at the heat-affected zone was observed at the higher side, which varies from 407-571 HV.

Figure 8. Welding – heat affected zone – Base metal (casting side) microhardness examination

In the failed sample, the Hardness at the heat-affected zone was observed at the higher side, which varies from 407-571 HV. The high Hardness at the heat-affected zone would increase strength and low ductility. The microstructure and Hardness produced in any ferritic steel heat-affected zone (HEAT-AFFECTED ZONE) depend on the cooling rate through the transformation temperature range of the steel/iron in question. This high hardness value indicates the less cooling time after welding.

A low heat balance led to rapid cooling as the weld deposited was small in relation to the parent material, and the parent material acted as a heat sink. The toughness can be low in microstructures that have arisen from rapid cooling rates. Finally, it forms crack-susceptible microstructures with poor toughness. This high Hardness might have contributed to the crack due to high localized stress.

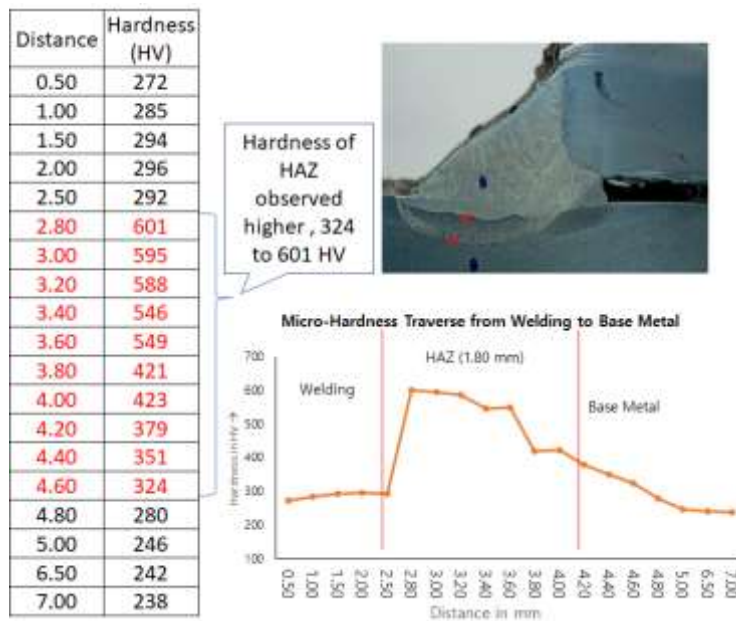
Without pre-heating, microhardness observations have been explained in Figure 10.

Figure 10. Without pre-heating welded sample - micro hardness observations

The analysis was carried out to understand the effect of no pre-heating on the part. The job needed to be pre-heated and welded. Micro-Hardness results show a high hardness value in the heat-affected zone area, resulting in the formation of tempered martensite, an unstable microstructure with high microhardness.

The job was not pre-heated and welded in the comparative study for analyzing the effect of pre-heating on the welding of stated grades of material. Micro-Hardness results show a high hardness value in the heat-affected zone area, resulting in the formation of tempered martensite, an unstable microstructure with high microhardness. With pre-heating at 150 to 200 deg. C, microhardness results show a high hardness value in the heat-affected zone area, resulting in the formation of tempered martensite, an unstable microstructure with higher microhardness in heat affected zone. With pre-heating at 200 to 250 deg. C, microhardness observations have been explained in Figure 12, and the hardness value recorded was within the standard limit.

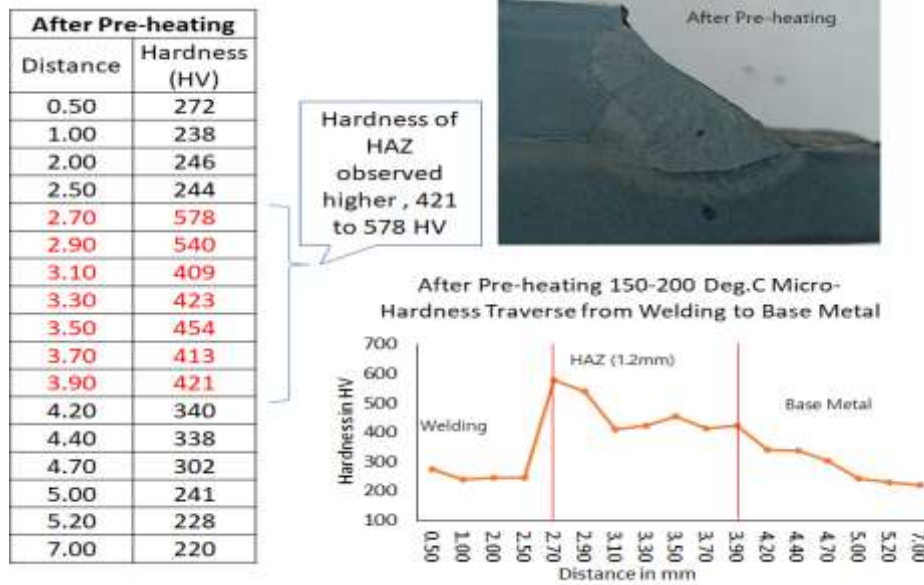
With pre-heating at 150 to 200 deg. C, microhardness observations have been explained in Figure 11. The analysis was carried out to understand the effect of less pre-heating on the part. The job was not pre-heated below the recommended pre-heat temperature and welded. The microhardness results show a high hardness value in the heat-affected zone area, resulting in the formation of tempered martensite, an unstable microstructure with higher microhardness in heat affected zone.

Figure 11. With 150-200 deg. C pre-heating welded sample - micro hardness observations
